## Bearing capacity diagnosis of Santiago church (Jerez de la Frontera, Spain)

The aim of this research has been to determine the causes of the damages located in Santiago church (Jerez de la Frontera, Spain), such as the collapse of the pillars, the wall and vault fissures and others, which have occurred over its five hundred year existence. The most significant aspects of the investigation works performed are related to the use of combined non-destructive techniques, such as the use of georadar with ultrasounds to detect voids inside pillars and main walls, videoscope, thermograph systems, accelerator and other seismic techniques, reducing up to 20% the excavations and unnecessary bore holes in order to know the composition and heterogeneities of the elements. In addition, by using these techniques, the deformation module E – dynamic and static – at different heights in pillars, as well as the bearing capacity could be obtained, not only among the pillars, but also at the bottom, central and upper parts of each pillar. An important goal of the investigation was to determine the extent of the reinforcement works developed in 1961, checking geometric features and conservation stat

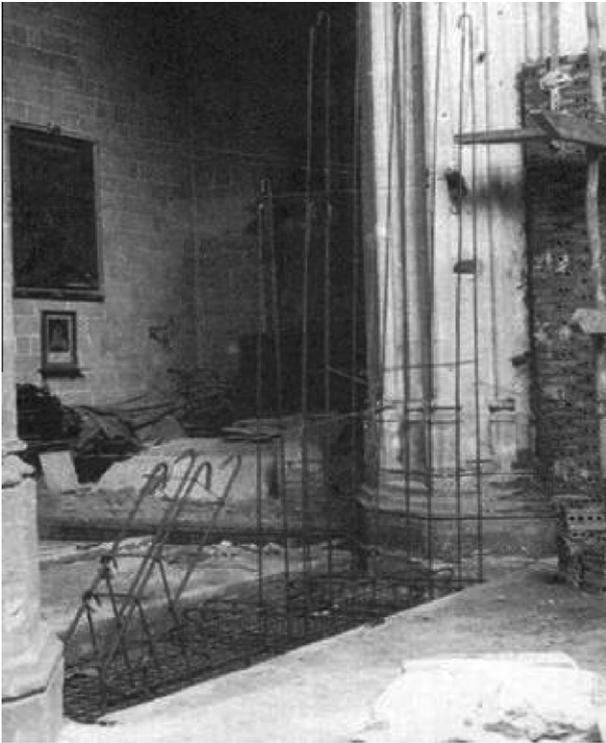
In 1961 restoration works began and the foundations were reinforced by placing a concrete tie beam (Fig. 4) (galleries were packed with demolition and waste materials); reconstruction of pillar 6 with the same stone ashlar and a light reinforced concrete core (Fig. 5), including arches and vaults, were built; similarly, adjacent pillars were strengthened substituting the existing core by light reinforced concrete after a vertical cut and hollowing out up to 10.50 m had been carried out. These works continued for five years.

Fig. 4. Foundation reinforcement with a tie beam (1961).

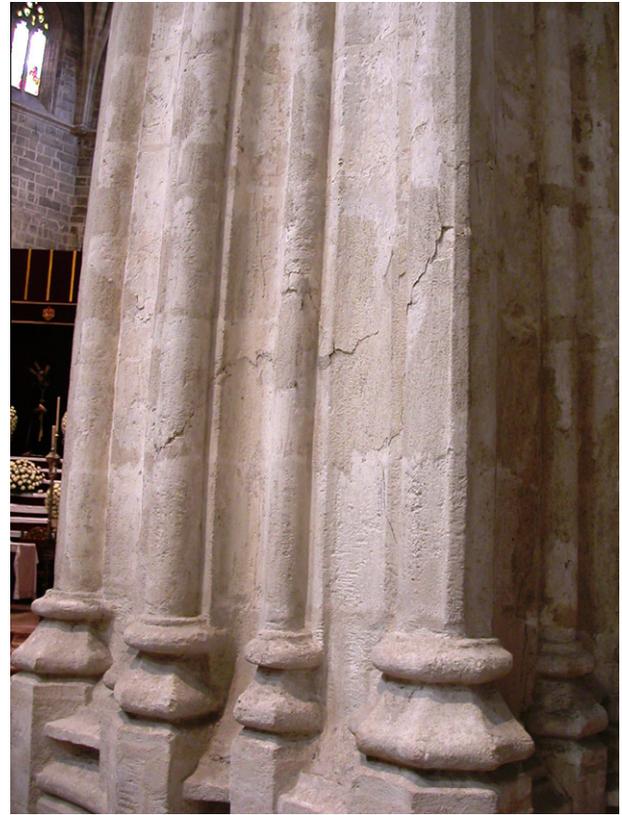
- Vertical cracks in almost all pillars, except for the one reconstructed by Rafael Esteve in 1905/06 (pillar 1). Pillars 4 and 5 had severe cracks with material detachment, typical of compression fracture. These cracks appeared mainly at the three lower meters (Fig. 6), that is a clear sign of flattening by excessive load or by the smaller bearing capacity of the element.

Fig. 6. Pillar 8 cracked by compression stresses.

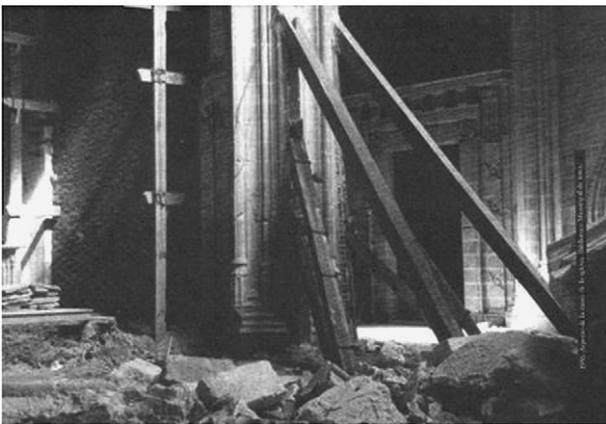
- On March 22nd 1956, during the restoration works, pillar 6, situated at the left aisle (the gospel aisle is located in the left side of an altar or church to a person looking from the nave toward the chancel) broke down and collapsed together with the vaults. An important part of the vaults detached and the section was noticeably reduced. However, four days before this had happened, the church had been examined and it did not show any sign of ruin, which shows that a compression fracture was the reason for this damage.

Fig. 5. Pillar 6 situation after the collapse of one of the sides, with the remains of the stretches fallen (1961 intervention).

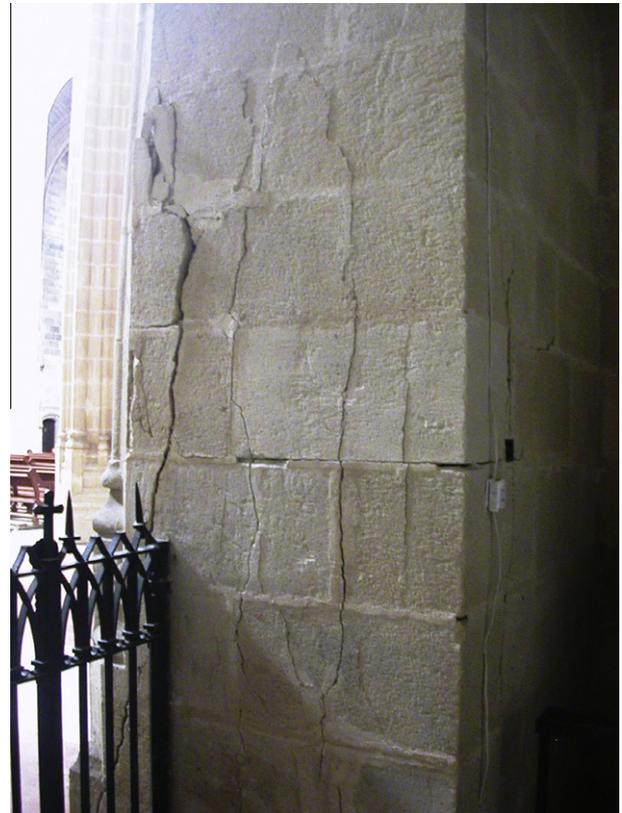
- Cracks and material detachments in different areas of the church wall, specifically in the area of the chancel chapel, where the wall showed fractures typical of the flattening by compression. In some points, the flattening of an area had also horizontal cracks, and in other cases, bulging of the outside skin of the wall could be seen.

- A burst out of the masonry on the solid wall had appeared at the left of the entrance to the Tabernacle chapel (Fig. 7), which is a clear sign of an excessive concentration of stresses.

Fig. 7. Wall cracked by compression stresses.

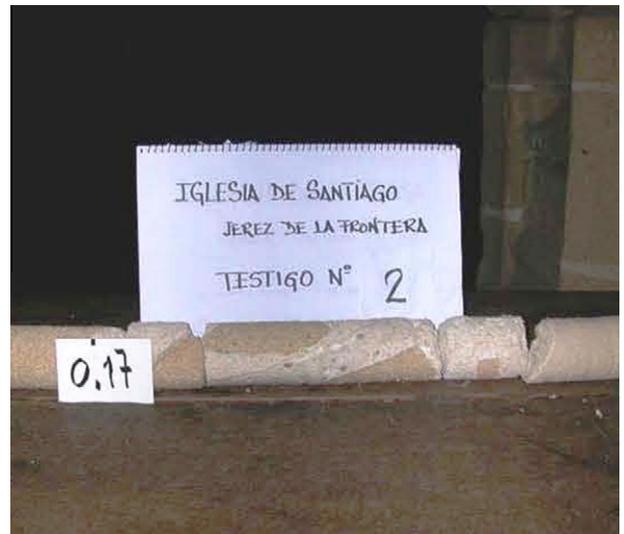
Fig. 9. Test showing composition of right lateral wall.

thick), solid brick masonry joined with lime mortar (70 cm), stone and ceramic piece agglomerate with low compactness lime mortar (Fig. 9) (65 cm) and stone ashlar masonry of bioclastic limestone joined with lime mortar (street façade). As a consequence of the re-growth performed in 1663 the whole section is of 237 cm.

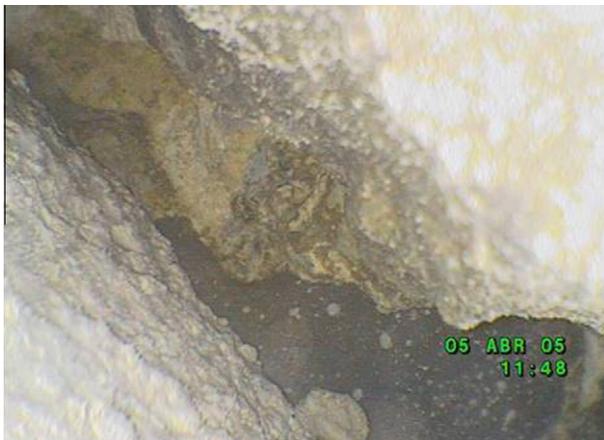
- Pillar 1. Rebuilt in 1906 by the architect Esteve. It is formed by calcarenite stone ashlar of greater compacity and greater resistance than that of the other pillars. The core is also made by stone ashlar, and as a consequence, the pillar is totally formed by stone.
- Pillar 2. Calcarenite stone ashlar masonry joined by lime mortar of thickness 20 cm covering the core made of stone pieces and lime. The result product is of low compactness. This pillar fell down and was replaced (1695–1699).
- Pillar 4. Skin of calcarenite stone ashlar (33 cm), and core of lime masonry aggregate with a low compactness and dispersed. It is the original one.
- Pillar 5. Constituted by calcarenite stone ashlar in the outer leaf and an agglomerate of stone pieces and lime in the core, where voids of almost 37 cm were found. It is the original one (Fig. 10).

Fig. 10. Void found with the videoscope inside 5.
