## Bearing capacity diagnosis of Santiago church (Jerez de la Frontera, Spain)

The aim of this research has been to determine the causes of the damages located in Santiago church (Jerez de la Frontera, Spain), such as the collapse of the pillars, the wall and vault fissures and others, which have occurred over its five hundred year existence. The most significant aspects of the investigation works performed are related to the use of combined non-destructive techniques, such as the use of georadar with ultrasounds to detect voids inside pillars and main walls, videoscope, thermograph systems, accelerator and other seismic techniques, reducing up to 20% the excavations and unnecessary bore holes in order to know the composition and heterogeneities of the elements. In addition, by using these techniques, the deformation module E – dynamic and static – at different heights in pillars, as well as the bearing capacity could be obtained, not only among the pillars, but also at the bottom, central and upper parts of each pillar. An important goal of the investigation was to determine the extent of the reinforcement works developed in 1961, checking geometric features and conservation stat

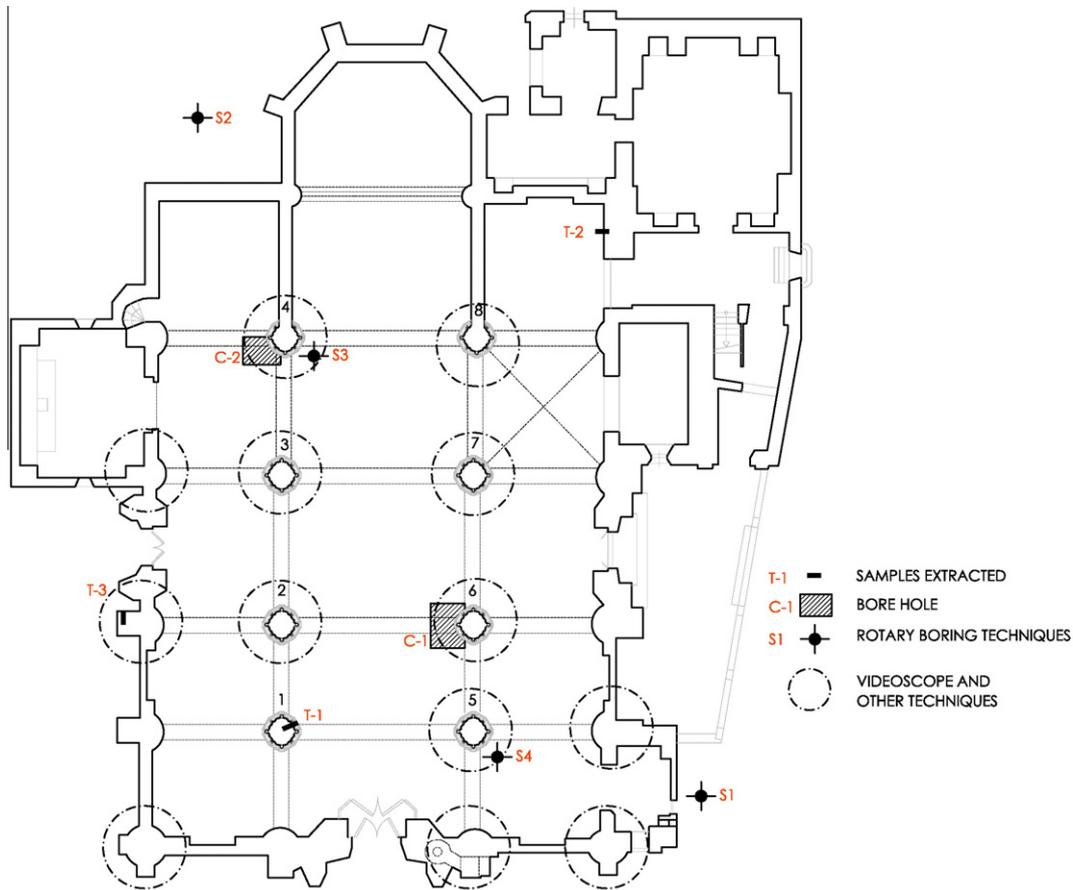
Fig. 8. Church plan showing the different tests performed.

In order to determine the foundations of the pillars, the technique of opening trial bore holes has been carried out (Fig. 8) [10,17]. Although it is a destructive test; it only affects the floor paving, as the excavation is done parallel to the pillar bases, without touching the existing masonry work.

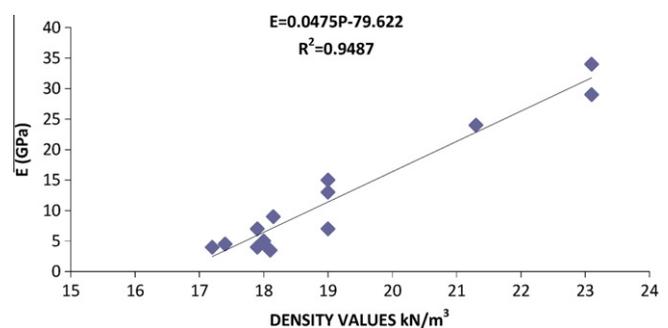
Fig. 11. Correlation between density values obtained in laboratory and static deformation calculated.

where  $E_{\text{static}}$  is the static Young module (GPa) and  $E_{\text{dynamic}}$  is the dynamic Young module (GPa). The following graph (Fig. 11) shows the existing correlation between the density values obtained in the laboratory and the static deformation module. As can be seen, both parameters have a 0.95 correlation degree.

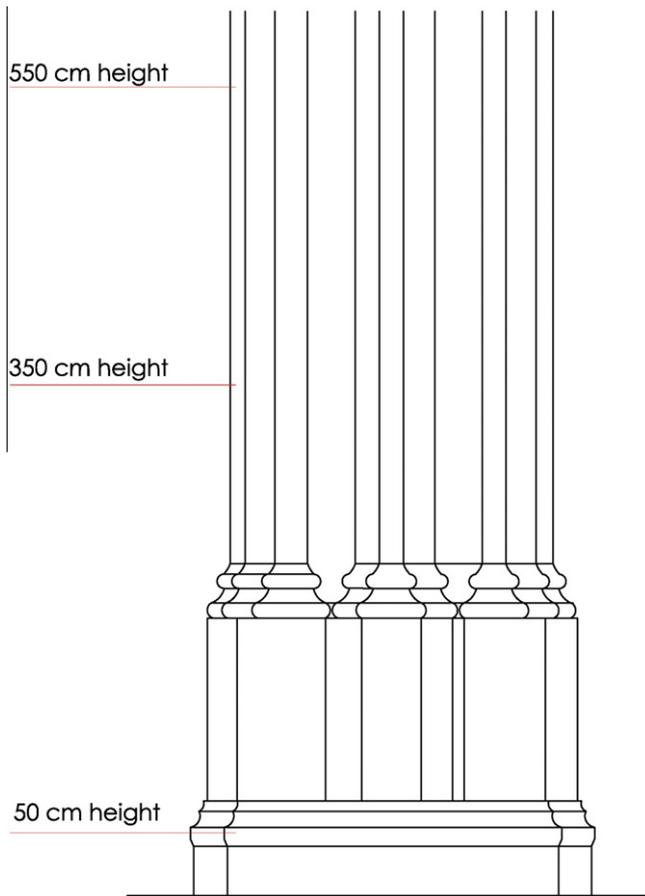
Fig. 12. Measuring points.

This seismic method consists on determining the time P and S waves (Fig. 13) take to cover the pillar section by using accelerometer recordings with a triaxial accelerometer, with a frequency range of 100 Hz to 6.5 kHz. Time measurements of the wave passing have been made at 50, 350 and 550 cm height (Fig. 12), and two measurements for each one of them (direction EW and NS). The distance between the translators has been obtained by digital cartography. From the speed values obtained, Poisson coefficient, rigidity module, volumetric compressibility module and Young module were then calculated (Table 2).

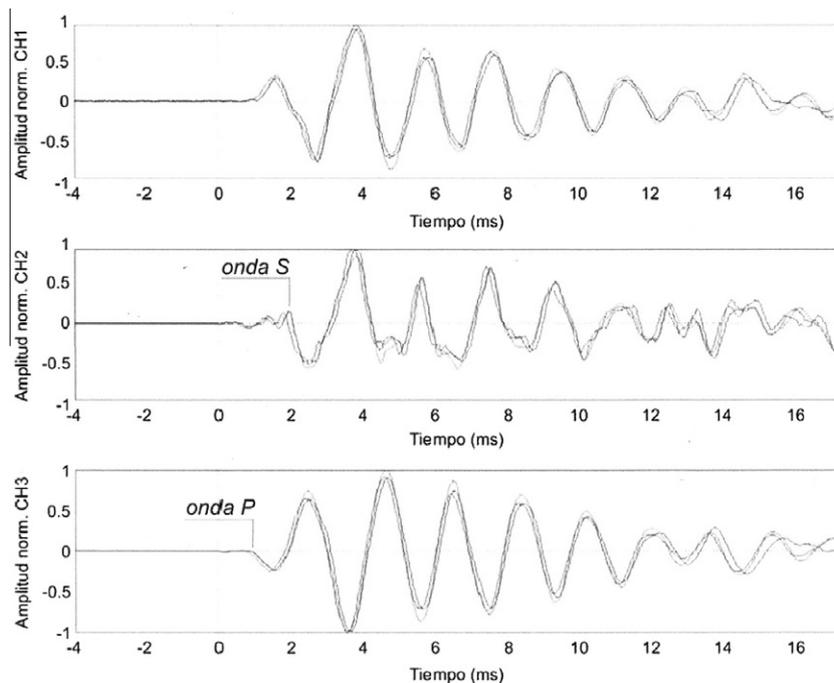
Fig. 13. Example of accelerograms processed from the recordings. Top: horizontal component (X) of the acceleration registered in the sensor. Centre: vertical component (Y) of the acceleration registered in the sensor. Bottom: compressive component (along the energy propagation direction) of the acceleration registered in the sensor. Ranges are standardized.
